# Imaging of Male Pelvic Trauma

Laura L. Avery, MD<sup>a,\*</sup>, Meir H. Scheinfeld, MD, PhD<sup>b</sup>

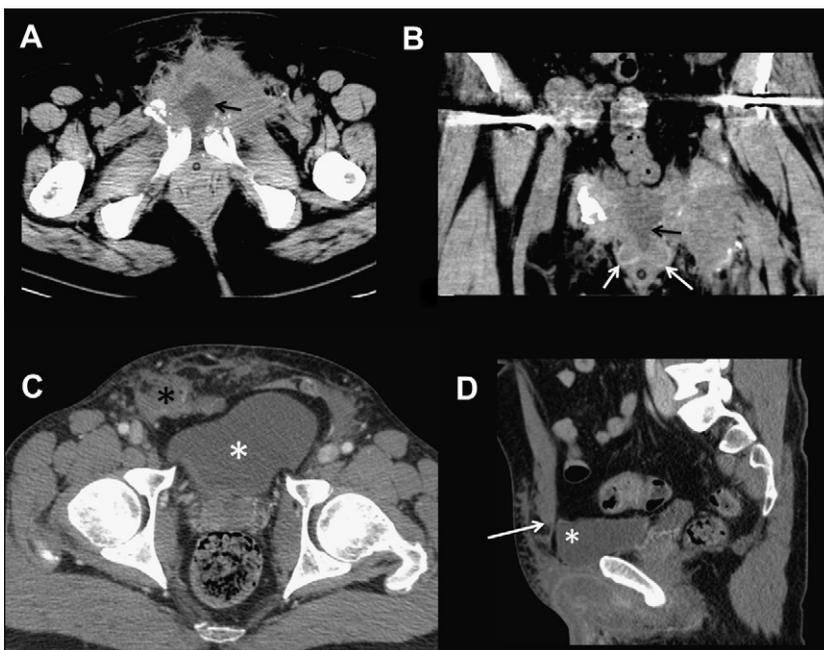
**Fig. 4.** Bladder hernia. (A) Axial contrast-enhanced CT scan from a patient who sustained an open-book fracture of the pelvis demonstrates bladder herniation through the pubic symphysis (*black arrow*) following orthopedic reduction. (B) Coronal image demonstrates the bladder (*black arrow*) to be resting on the dorsum of the penis (*white arrows*). (C and D) Axial and sagittal CT scans from a different patient who also sustained an open-book pelvic fracture demonstrates herniation of the bladder (*white asterisk*) over the pubis secondary to avulsion of the inferior rectus abdominis tendon (*white arrow*) with adjacent hematoma (*black asterisk*).

Bladder hernia is an uncommon complication of pelvic trauma and occurs secondary to a traumatic abdominal wall hernia or pelvic ring disruption. Bladder hernia may be seen in the setting of pubic symphysis diastasis, such that the bladder is trapped between the pubic bones (**Fig. 4**). When this is discovered, it must be relayed promptly to the orthopedic team to prevent bladder entrapment or injury that may occur during pelvic reduction or surgery.<sup>27-29</sup> Rupture of the rectus abdominis muscle or avulsion of its tendon from the pubis may occur after a blunt or penetrating anteroposterior force to the pelvis. This defect may be an additional site of bladder herniation and entrapment (see **Fig. 4**).

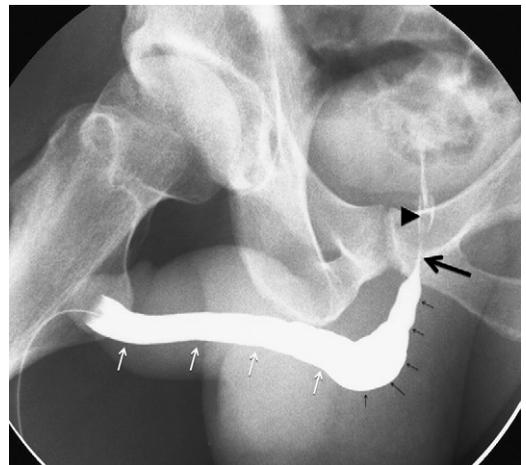
**Fig. 6.** Normal retrograde urethrogram with filling of the entire urethra. The prostatic urethra demonstrates the normal impression of the verumontanum (*black arrowhead*). The membranous urethra is the narrowest portion of the urethra on the normal urethrogram (*large black arrow*). Small black arrows denote the bulbar portion of the anterior urethra. The white arrows denote the penile portion of the anterior urethra.

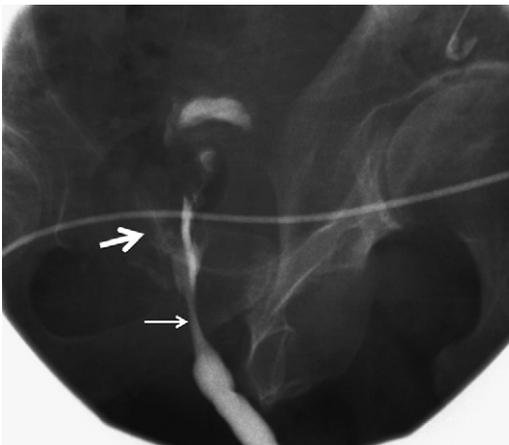
**Fig. 8.** Type II urethral injury. Contrast extravasation is seen adjacent to the prostatic urethra (*large white arrow*). Contrast does not extend below the intact urogenital diaphragm, indicated by the membranous urethra (*small white arrow*).

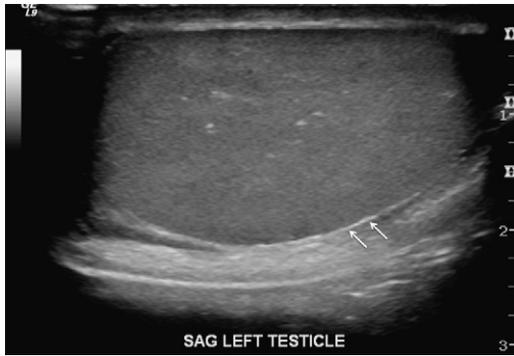
**Fig. 12.** Normal testicular ultrasound. The normal testicle has homogeneous intermediate echotexture. Arrows define the thin echogenic tunica albuginea, which surrounds the testicle.

The visceral layer of the tunica vaginalis is closely attached to the tunica albuginea of the testis. The tunica albuginea is a fibrous capsule that covers the testis and appears on ultrasound as an echogenic rim surrounding the testis (**Fig. 12**). Additionally, the fibrous nature of the
